# **ANALYSIS OF A STORM – JUNE 2007**

**ABSTRACT:** A series of storm systems impacted coastal regions between the Illawarra and the Hunter during June 2007. Although each separate storm was characteristically quite different, collectively, these storms resulted in widespread flooding and wind damage, coastal erosion, a record number of callouts for State Emergency Service assistance, grounding of the Pasha Bulker, (a 40,000 tonne bulk coal ship) on Nobbys Beach and the tragic loss of 9 lives.

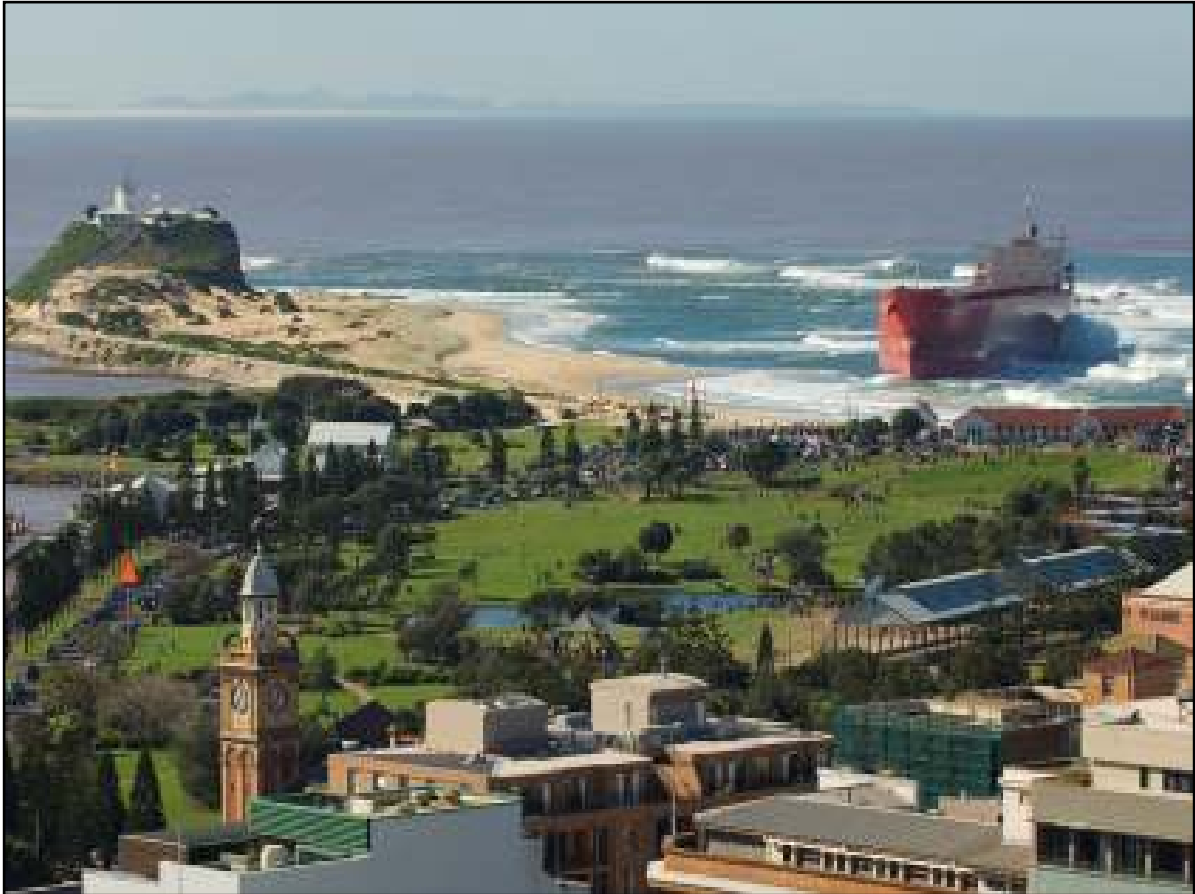
**Figure 1:** Bulk ore carrier “*Pasha Bulker*” which ran aground on Nobbys Beach during the wild weather on 8<sup>th</sup> June 2007. Photo courtesy Newcastle Morning Herald online news service.

On Thursday night (7<sup>th</sup>) the low deepened to 1009hPa just north of Newcastle. Gale force south easterly winds started about midnight and continued for 12 hours. It was during this timeframe that several bulk carrier ships waiting offshore of Newcastle Port encountered difficulties with dragging anchors. Three ships (*Betis*, *Sea Confidence* and *Pasha Bulker*) were in distress, but only the *Pasha Bulker* was unable to avoid catastrophe, running aground across the rocky reefs on Nobbys Beach around mid-morning. Fortunately, the 40,000 tonne bulk carrier was successfully salvaged from the beach at 9.40pm on Monday 2 July, after 25 days of being pounded by heavy seas which damaged the outer hull of the vessel (NPC, 2007).

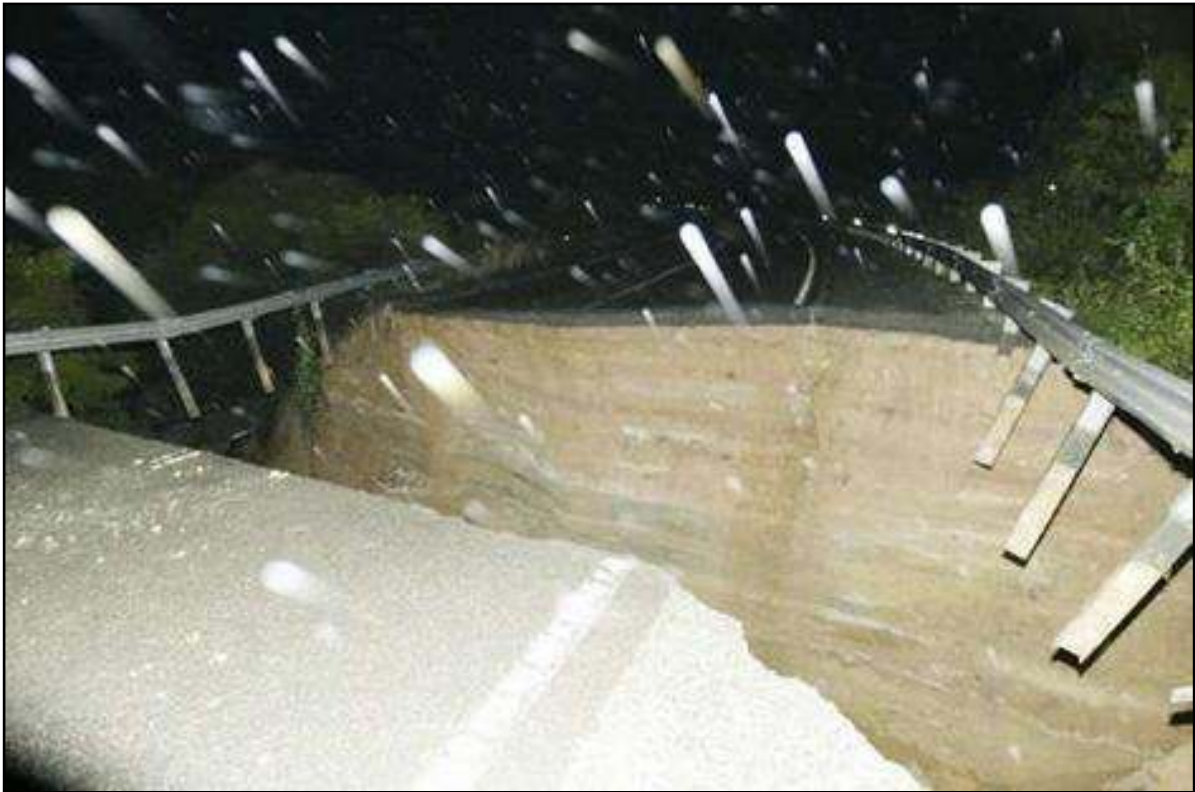
**Figure 2:** Old Pacific Highway road collapse at Somersby, NSW Central Coast, 8<sup>th</sup> June 2007. Photo: Courtesy Daily Telegraph online news service.

Around noon on Friday 8<sup>th</sup> the low near the coast weakened and the winds eased, but from 3.30pm until 7.30pm a persistent line of thunderstorms over Newcastle and northern parts of Lake Macquarie resulted in severe rainfall and flash flooding in areas of the Central Coast, Newcastle and the Hunter Valley. Just after 4.00pm, two adults and three children were tragically killed when the car they were travelling in was swept away as a portion of the old Pacific Highway collapsed leaving a 10m wide abyss into the swollen Piles Creek below (DT, 2007).

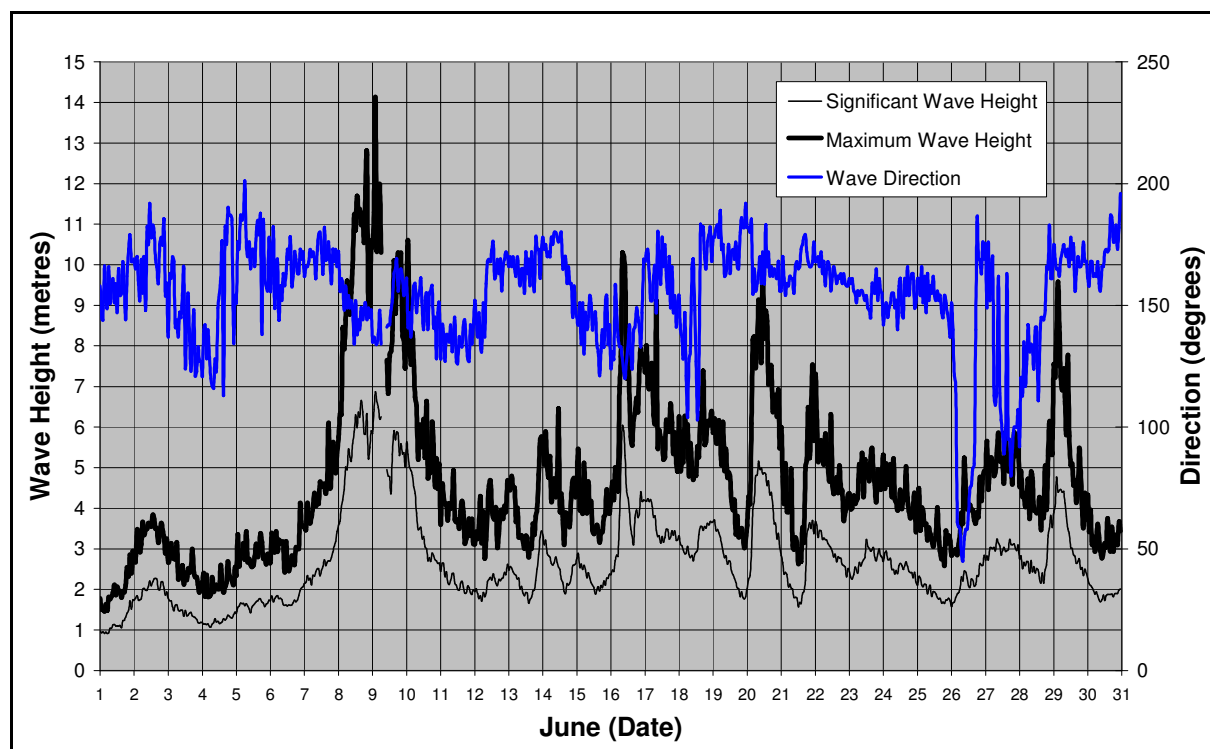
**Figure 3:** Sydney deepwater directional Waverider buoy data (Source: Manly Hydraulics Laboratory)

Although the maximum wave height recorded at the Sydney deepwater Waverider buoy during June occurred during the long-weekend storm, the storm threshold was triggered on a further 14 occasions during the month.  $H_{sig}$  exceeded 3m for a total of 208 hours, some 29% of the month (Refer Figure 3).

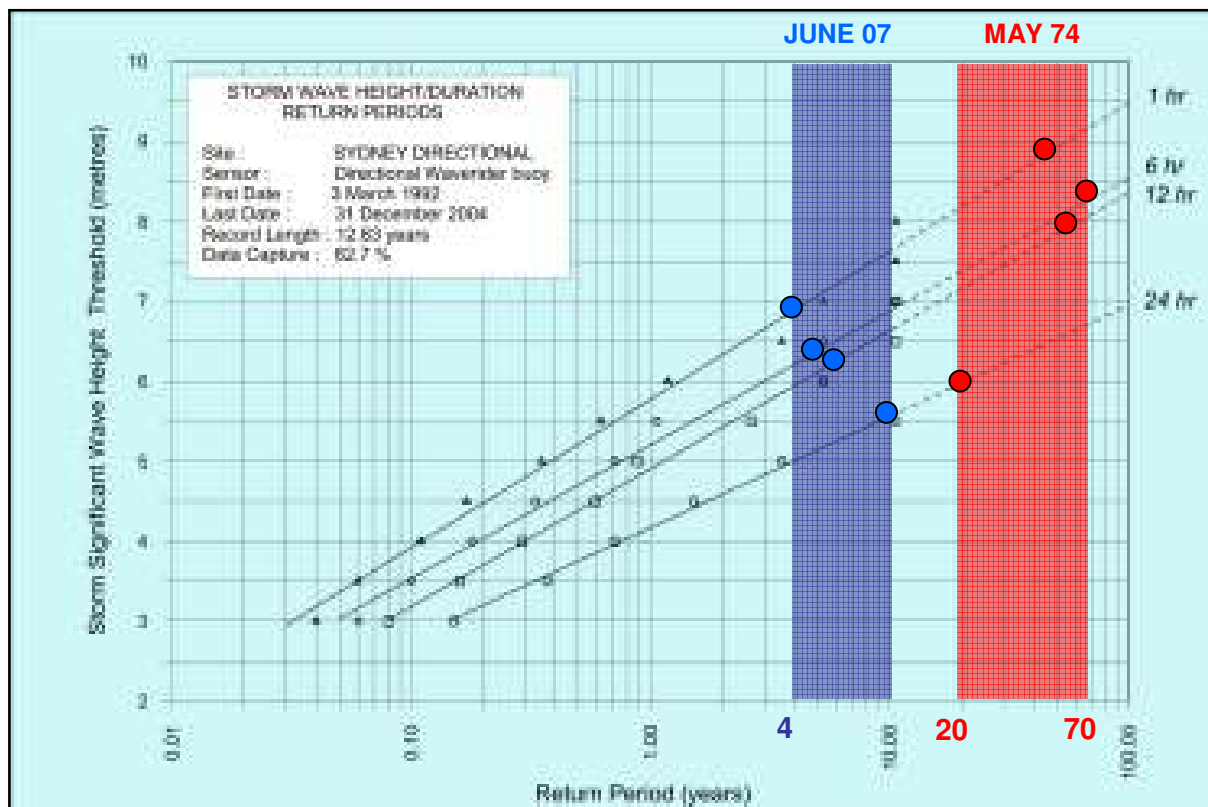
**Figure 4:** Combined storm wave height duration return periods for Sydney directional Waverider buoy (Source: Manly Hydraulics Laboratory)

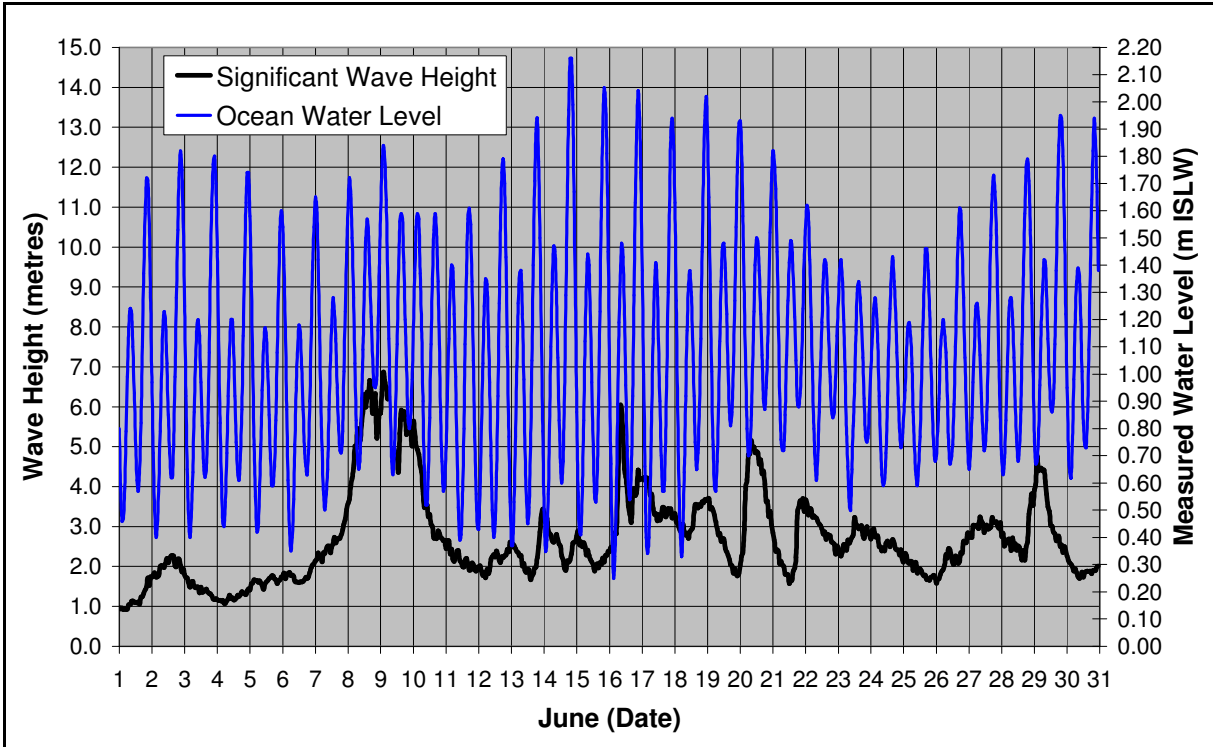
**Figure 5:** Combined  $H_{sig}$  (Sydney directional Waverider buoy) and measured ocean water level from Middle Head, Sydney tide gauge facility (Source: Manly Hydraulics Laboratory).

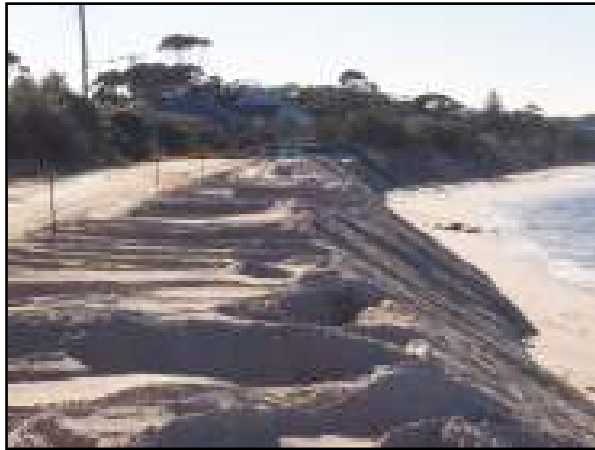
**Figure 6a:** Emergency dumping of sand to save the road at Jimmys Beach during June long weekend (Courtesy Department Environment & Climate Change)

A difference of some 30cm in base ocean tide levels would have significantly worsened the flash flooding impacts, riverine flooding and tailwater effects and dramatically heightened the likelihood of very severe coastal erosion, particularly between Sydney and Port Stephens. The ICA still ranked this particular storm the 2<sup>nd</sup> largest natural disaster in Australian history. The primary impacts over the long-weekend were felt from flash flooding and damage from fallen trees. However, sustained swell wave activity during the month of June also had a cumulative impact on eroding many NSW beaches, primarily south of Crowdy Head. Examples are shown in Figures 6a – 6h.

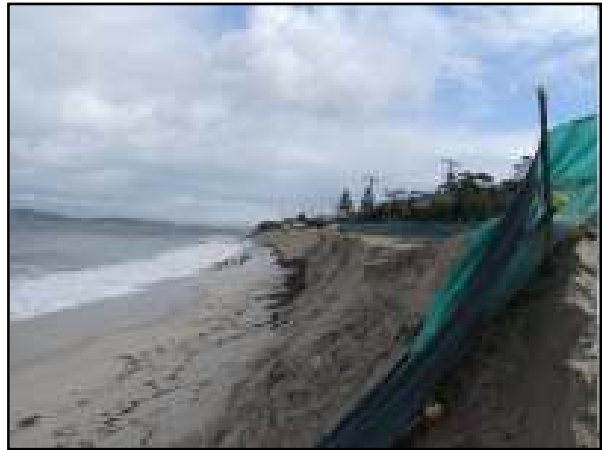
**Figure 6b:** Jimmys Beach erosion 9<sup>th</sup> June 2007 (Courtesy ABC News Online)

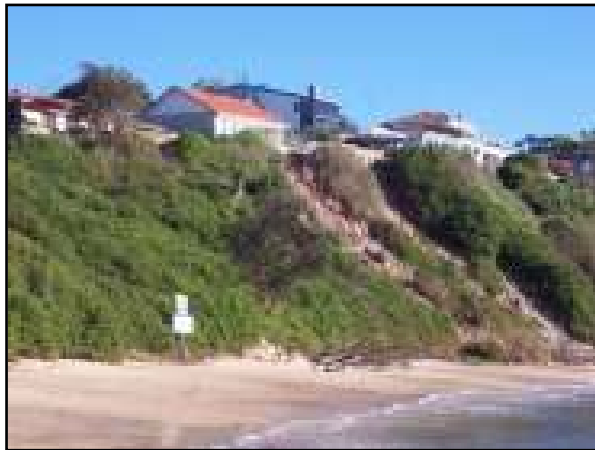
**Figure 6c:** Landslide at Cabbage Tree Harbour, Norah Head on 22<sup>nd</sup> June 2007 (Courtesy Department Environment & Climate Change)

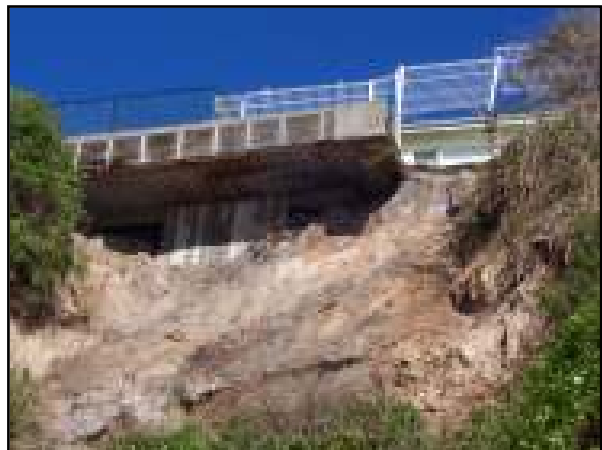
**Figure 6d:** Landslide at Cabbage Tree Harbour, Norah Head exposing overhanging deck structure on 22<sup>nd</sup> June 2007 (Courtesy Department Environment & Climate Change)

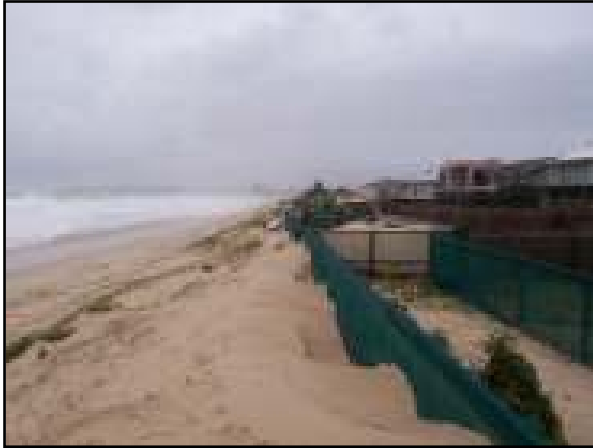
**Figure 6e:** Windblown sand burying backyards along Curtis Parade, North Entrance on 9<sup>th</sup> June 2007 (Courtesy Department Environment & Climate Change)

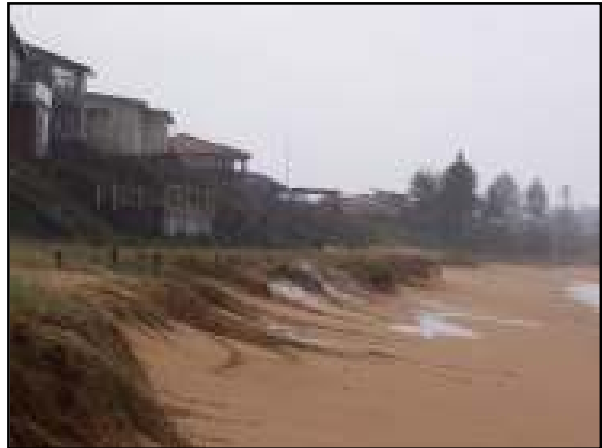
**Figure 6f:** Erosion along Wamberal Beach on 9<sup>th</sup> June 2007 (Courtesy Department Environment & Climate Change)

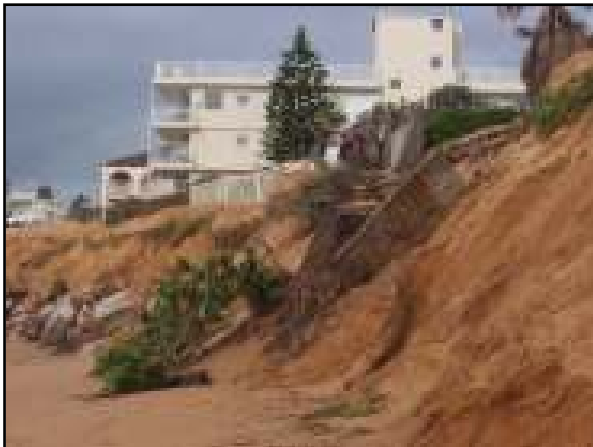
**Figure 6g:** Erosion along Collaroy/Narrabeen Beach on 18<sup>th</sup> June 2007 (Courtesy Department Environment & Climate Change)

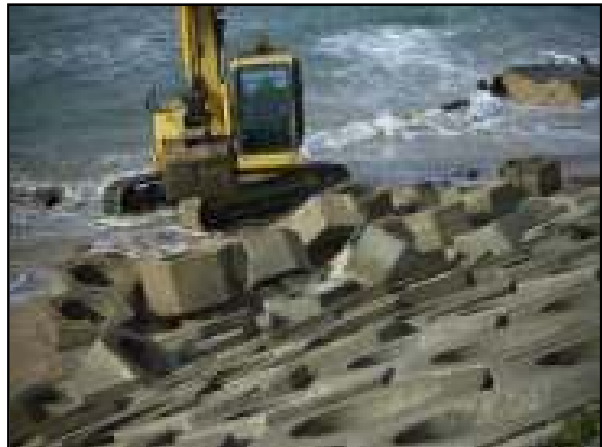
**Figure 6h:** Repairs to damaged seawall at Prince Street, Cronulla (Courtesy Department Environment & Climate Change)
